RotaCut®: Trouble free dewatering

Case Study - hanseWasser Bremen GmbH

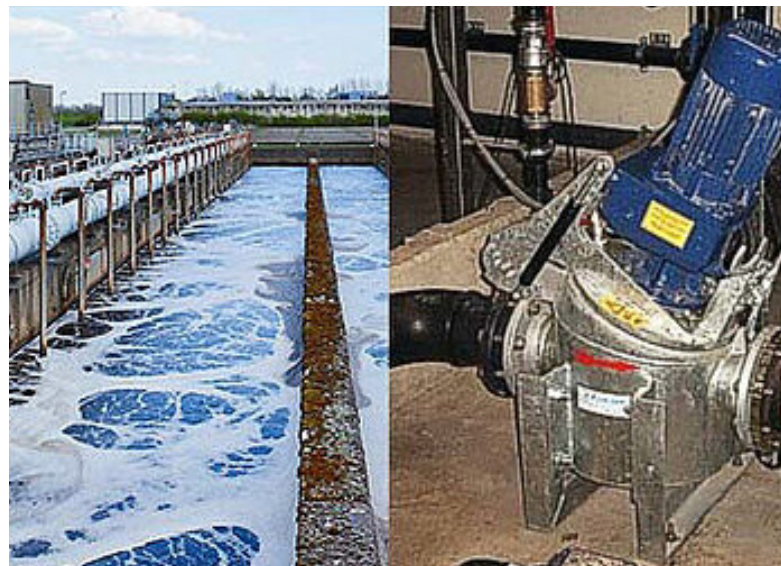
„We installed two RotaCut Inline macerators with ACC in front of the centrifuges to treat the sludge before feeding to the centrifuges. Thanks to the homogeneous sludge without long fibers, malfunctions are avoided and dewatering runs safer,“ said Mr. Weddermann from hanseWasser.

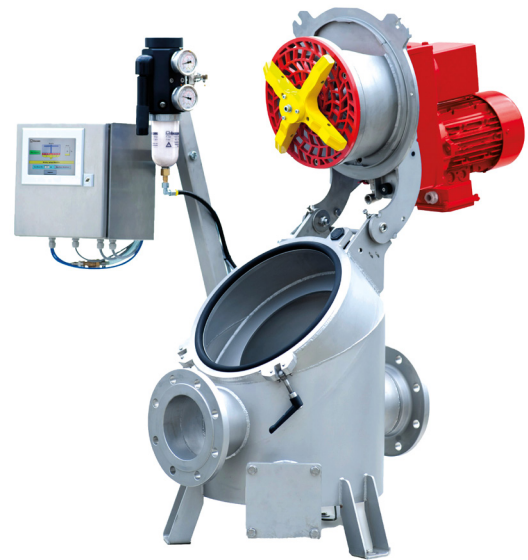
Vogelsang RotaCut

RotaCut reliably chops down all fibers and rags in the sludge. The ACC adjusts the blades automatically keeping an even pressure at all times. Furthermore, the sludge is homogenised in the process, which provides smooth operations of the centrifuges. Malfunctions, operational interruptions and unnecessary maintenance for trouble shooting are avoided with RotaCut and ACC.
