RotaCut®: Trouble free dewatering

Case Study - hanseWasser Bremen GmbH

Malfunctions of centrifuges in dewatering

RotaCut RC 5000 Inline with ACC

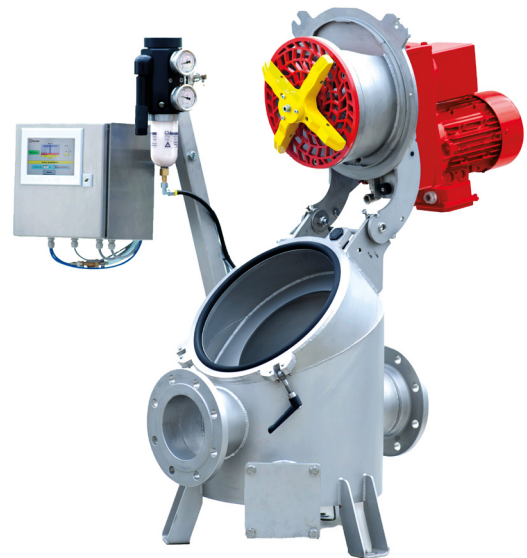
Vogelsang RotaCut

RotaCut reliably chops down all fibers and rags in the sludge. The ACC adjusts the blades automatically keeping an even pressure at all times. Furthermore, the sludge is homogenised in the process, which provides smooth operations of the centrifuges. Malfunctions, operational interruptions and unnecessary maintenance for trouble shooting are avoided with RotaCut and ACC.

„We installed two RotaCut Inline macerators with ACC in front of the centrifuges to treat the sludge before feeding to the centrifuges. Thanks to the homogeneous sludge without long fibers, malfunctions are avoided and dewatering runs safer,“ said Mr. Weddermann from hanseWasser.
