RotaCut®: Trouble free fecal sludge receiving

Case Study: WWTP Krefeld

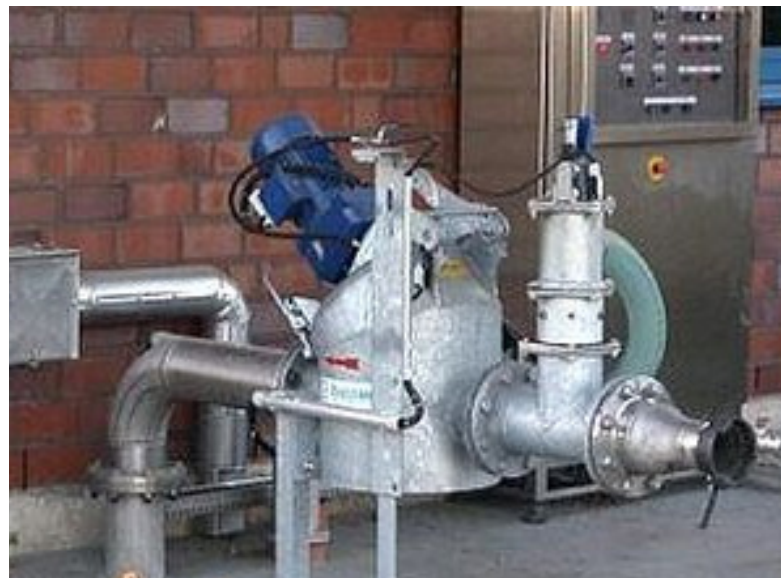
Vogelsang RotaCut RC 5000 Inline

After the RotaCut has been installed as protection, it reliably separates all heavy solids. At the same time, fibers and coarse matter are macerated and even larger wooden parts are reduced to an unproblematic size thanks to the AutoReverse function. Blockages and damage to the pumps are a thing of the past.

Thanks to the inline design, no changes at the pipework were necessary. The RotaCut could easily be integrated into the existing pipework. It is therefore not surprising that the RotaCut was also chosen for the expansion. Today, 20-30 trucks unload their charge every day at the three septage receiving station.
