# RotaCut®: Trouble free dewatering

## Case Study - hanseWasser Bremen GmbH

Malfunctions of centrifuges in dewatering

RotaCut RC 5000 Inline with ACC

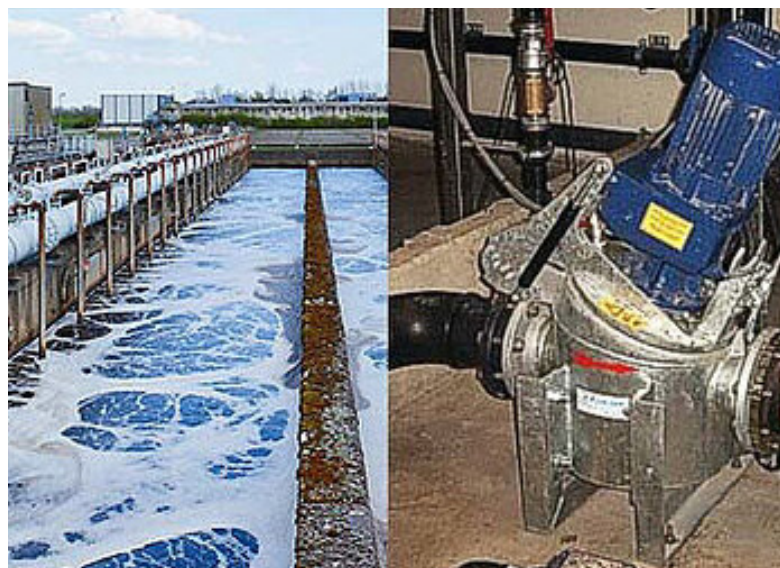
***„We installed two RotaCut Inline macerators with ACC in front of the centrifuges to treat the sludge before feeding to the centrifuges. Thanks to the homogeneous sludge without long fibers, malfunctions are avoided and dewatering runs safer,“ said Mr. Weddermann from hanseWasser.***

RotaCut reliably chops down all fibers and rags in the sludge. The ACC adjusts the blades automatically keeping an even pressure at all times. Furthermore, the sludge is homogenised in the process, which provides smooth operations of the centrifuges. Malfunctions, operational interruptions and unnecessary maintenance for trouble shooting are avoided with RotaCut and ACC.
