# RotaCut®: Trouble free fecal sludge receiving

## Case Study: WWTP Krefeld

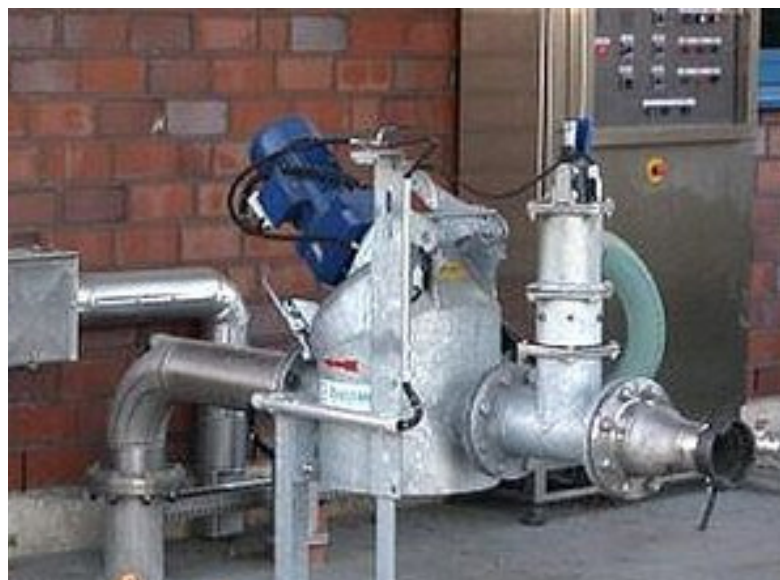
Vogelsang RotaCut RC 5000 Inline

After the RotaCut has been installed as protection, it reliably separates all heavy solids. At the same time, fibers and coarse matter are macerated and even larger wooden parts are reduced to an unproblematic size thanks to the AutoReverse function. Blockages and damage to the pumps are a thing of the past.

Thanks to the inline design, no changes at the pipework were necessary. The RotaCut could easily be integrated into the existing pipework. It is therefore not surprising that the RotaCut was also chosen for the expansion. Today, 20-30 trucks unload their charge every day at the three septage receiving station.

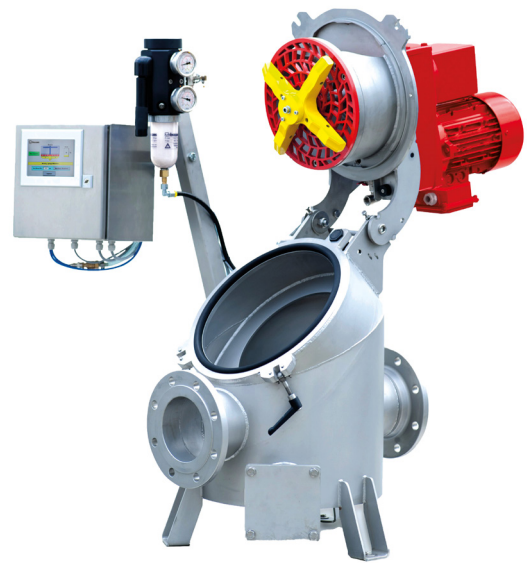
**Vogelsang RotaCut**

- Excellent separation of heavy objects (stones, metal pieces etc.)
- Reliable size reduction of coarse material and fibers (cleaning cloths, pieces of wood etc.)
- Easy to retrofit due to the Inline design
