# RotaCut®: Trouble free dewatering

## Case Study - hanseWasser Bremen GmbH

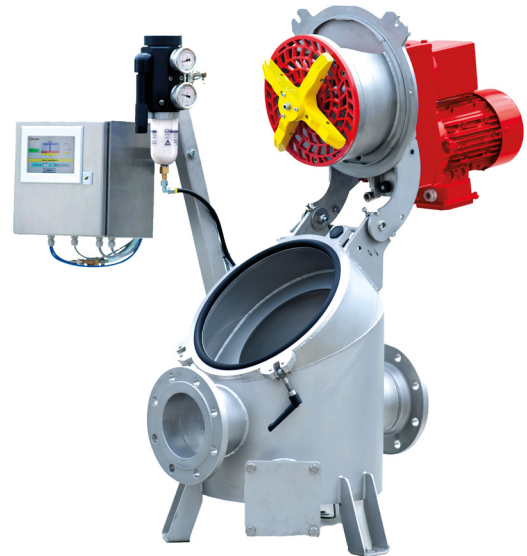
**Vogelsang RotaCut**

RotaCut reliably chops down all fibers and rags in the sludge. The ACC adjusts the blades automatically keeping an even pressure at all times. Furthermore, the sludge is homogenised in the process, which provides smooth operations of the centrifuges. Malfunctions, operational interruptions and unnecessary maintenance for trouble shooting are avoided with RotaCut and ACC.

- Reliable maceration of fibers and rags
- Sludge is homogeneous and flow able
- Automatic blade adjustment
- Protects equipment and ensures trouble free and smooth operation of dewatering
